## Comments on recent MAIB reports on the groundings of Pride of Canterbury and CFL Performer by David Edmonds

### ***The Importance of Scale & Safety Contour Settings***

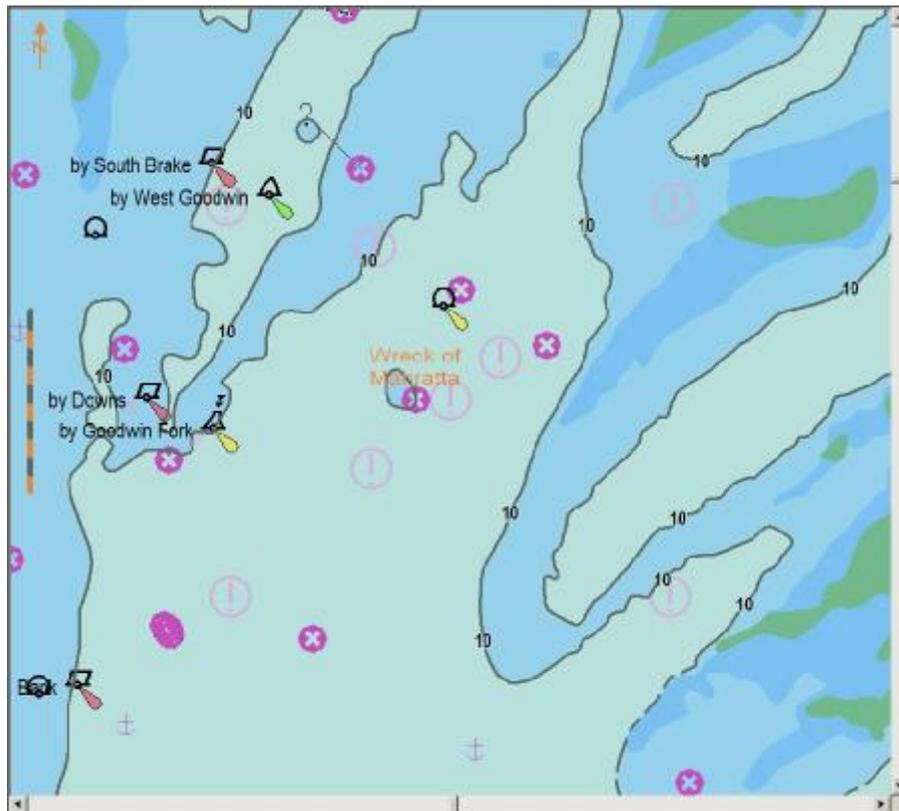
Figure 3 ENC scale 1:45000 hazards beneath safety contour shown

A similar regime applies to ENCs. With safety contour set to 10m, cell GB40282A (1:22000) and GB302820 (1:45000) (Figure 3) clearly show the danger symbol, representing the wreck; but zoom out to GB202900 (1:90,000) (Figure 4) and the hazards disappear.

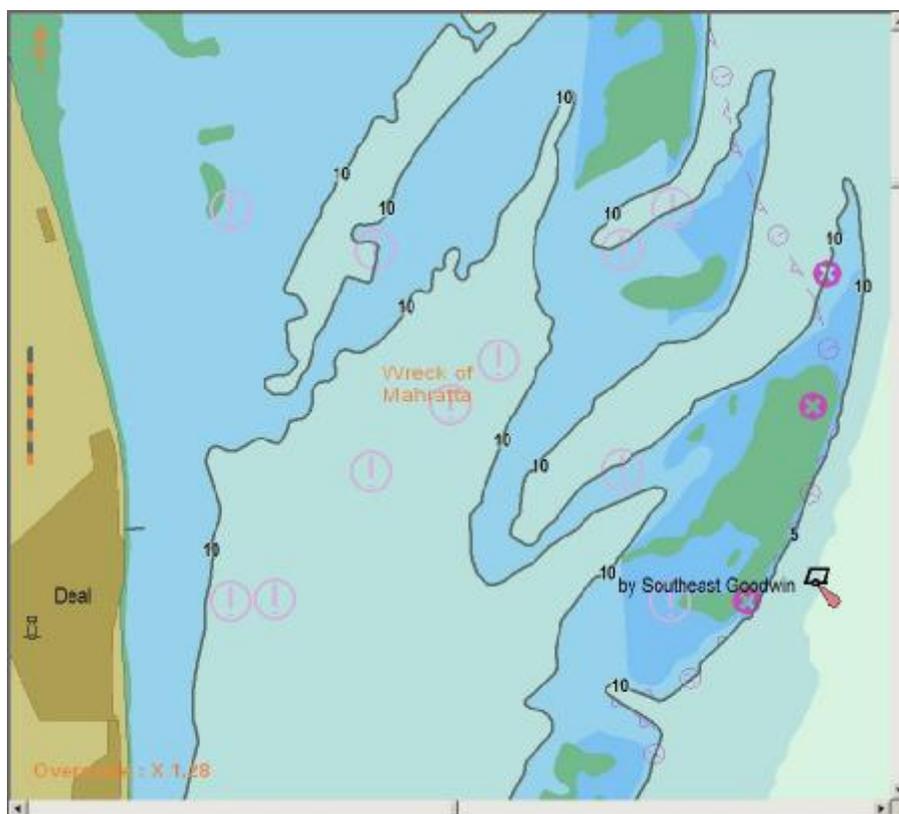
Figure 4 ENC Scale 1:90,000 no hazard information

One can imagine why the navigator might choose to zoom out to this level on ECDIS, because at this scale he can see the coastline, but it is not an appropriate scale for the task in hand.

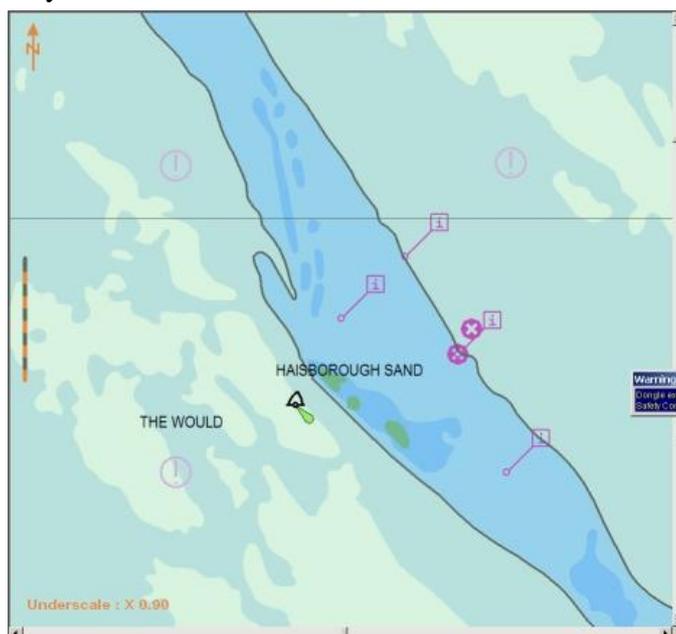
With the default 30m safety contour setting Haisborough Sand does not stand out so well whereas with a 10m setting it is very clear indeed.

**Figure 6 10m safety contour applied**

However, in the case of CFL Performer, although a safety contour alarm is mandatory under ECDIS standards, it was possible on the particular ECDIS onboard for this alarm not to be activated by simply not setting a vector length for the alarm. If, as seems the case, the operators had not received training in the operation of the ECDIS, and were unaware of the need to set a vector for the safety contour alarm or even that this feature existed, it is likely that they had been sailing for some time without ever receiving the type of alarm that could have saved them from grounding. Moreover, had they set their safety contour to an appropriate level (10m) Haisborough Sand would have been

highlighted and hopefully they would have seen that they were on an inappropriate route (Figures 5 & 6).
